Master Thesis

Spatio-temporal changes of Vistula riverbed below the Włocławek hydropower plant

A thesis submitted in partial fulfilment of the requirements of
the degree of
Master of Science (Geographical Information Science & Systems) – MSc (GISc)

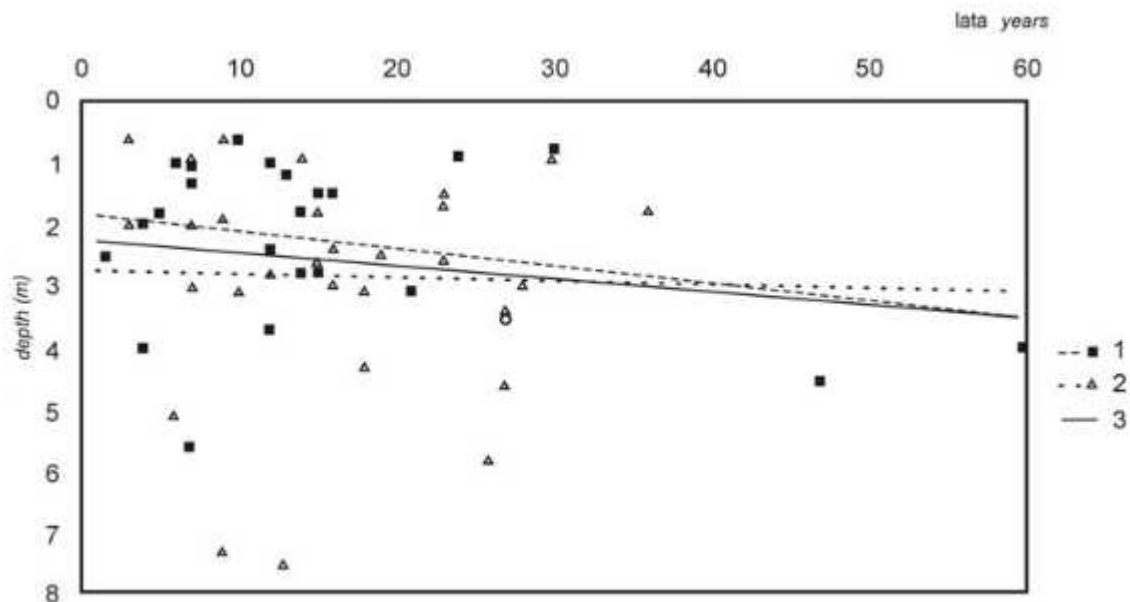
Figure 1 The rate of riverbed degradation below selected dams in the world (m) and it's straight regression (on the basis of data from Table 1)

1 – American rivers, 2 – other rivers of the northern hemisphere, 3 – all analysed rivers

The large spread of measurement points and low coefficient of regression for three lines (less than 0,5), indicate a lack of correlation between these characteristics. Nevertheless, the general tendency of riverbed incision over time can be stated in all cases. It is found that erosion process occurred most intensively in the first years after damming period. The greatest decreases of riverbed were then noted. Moreover, erosion below dams usually took values within the range of 2 – 4 m (Babiński 2002).

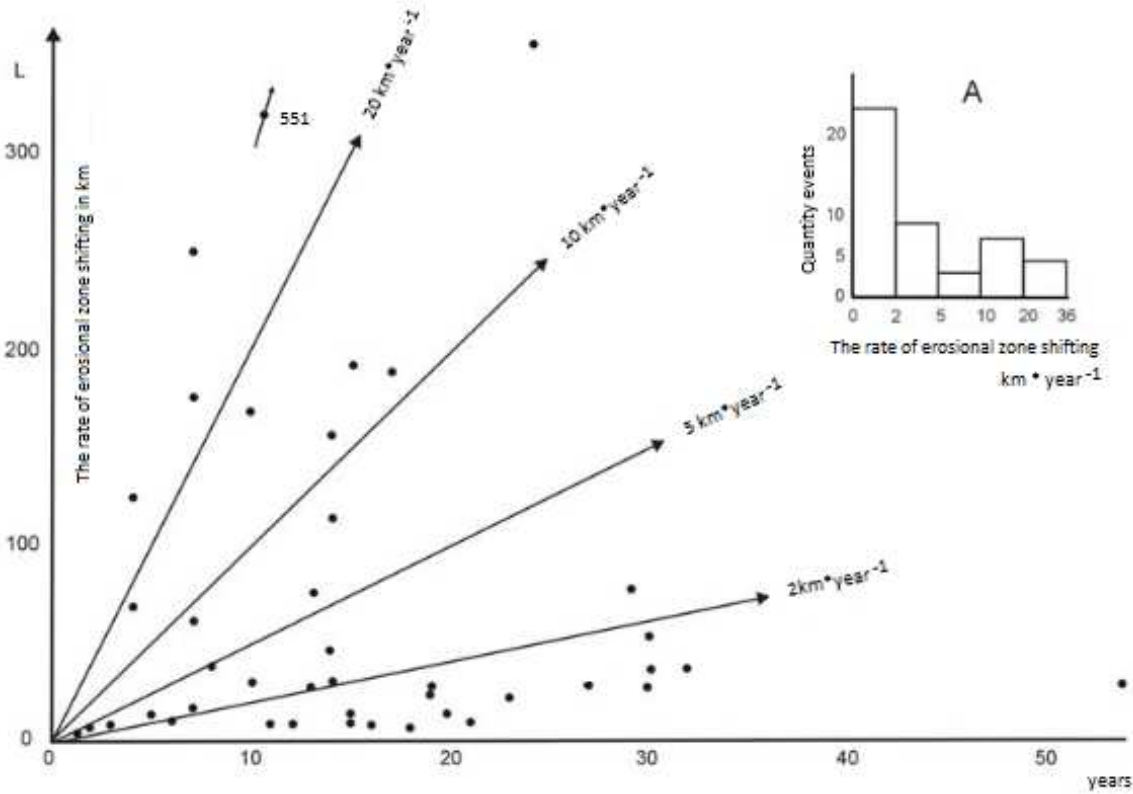
Figure 2 The rate of erosional shifting on the basis of selected rivers in the world

A – Quantity events in erosional zone shifting group

An important element in determination the extent of riverbed erosion below dams, in addition to riverbed incision, is the study of the reach of erosion zone and the rate of its shifting. On the basis of the studies, it was found that in all analysed cases development of erosion zone was the most dynamic in the first years of dam operation as well (Figure 2). Record – holder is Colorado River (USA), where after 6 months of hydrofacility activity erosion zone has moved to a distance of 21 km, which gave the highest rate in the

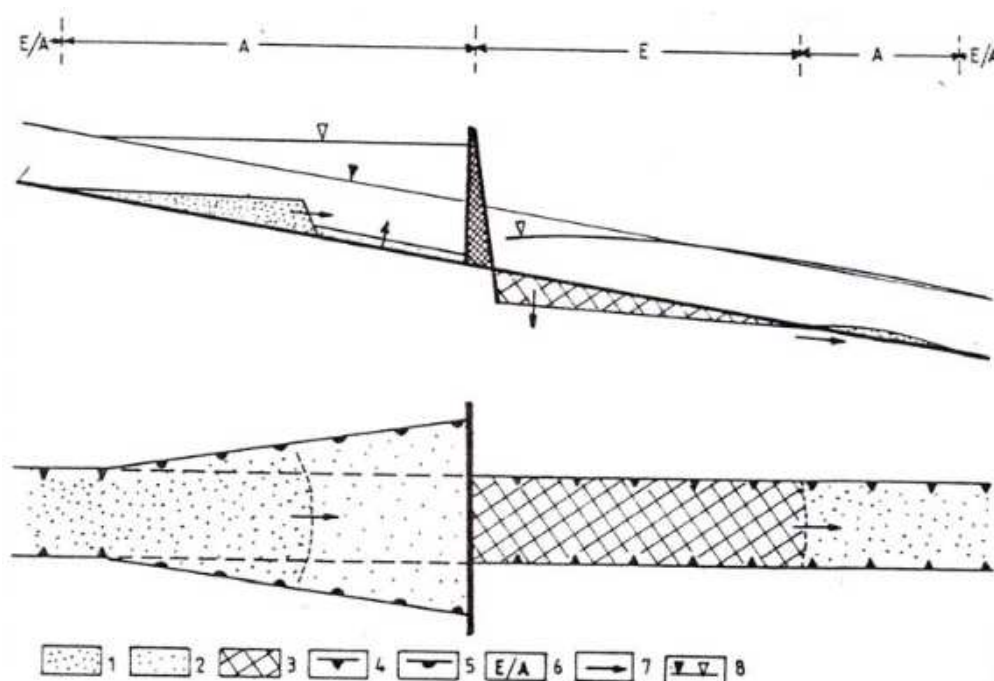
Figure 3 Influence of a dam on fluvial processes in alluvial rivers

1 – zone of bed load accumulation; 2 – zone of suspended load accumulation; 3 – erosional zone; 4 – side erosion; 5 – abrasion; 6 – segments of different degree of channel development (E/A – transit, A – accumulation, E – erosion); 7 – direction of fluvial processes; 8 – water level before and after dam construction

The studies conducted by Schumm 1969, Gregory et al. 1974, Emmett 1974, Knox 1977, Williams et al. 1984, Hooke 1997, Grams et al. 2002, Downs et al. 2004, Gregory 2006 allowed for identification a general model of riverbed degradation downstream from the dam (Chien 1985). Its characteristics was developed on the basis of exemplary 150 river sections around the world (Figure 3) (Babiński 2007).

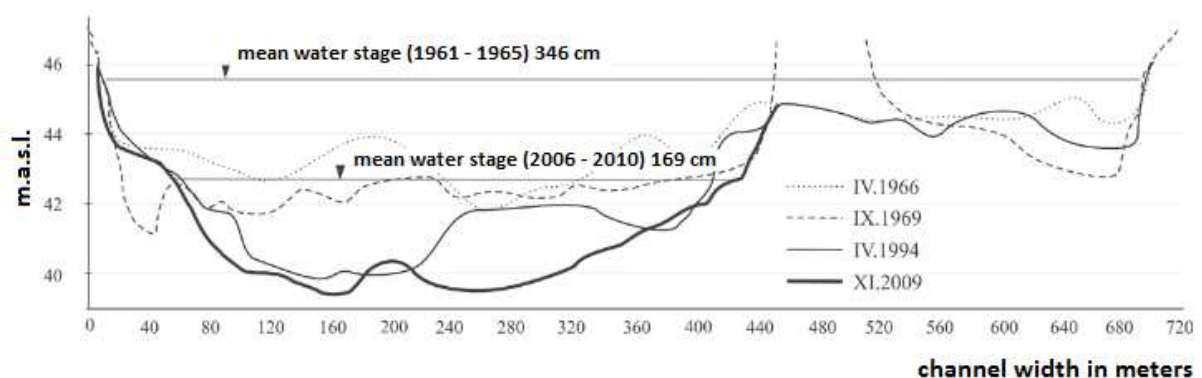
Figure 4 Changes in cross – section of Vistula river at the gauging profile in Włocławek

Comparison of the studies conducted (Habel 2013) for decadal perspective, i.e. 1969 – 2009 represent a constant trend of channel incision (Figure 4).

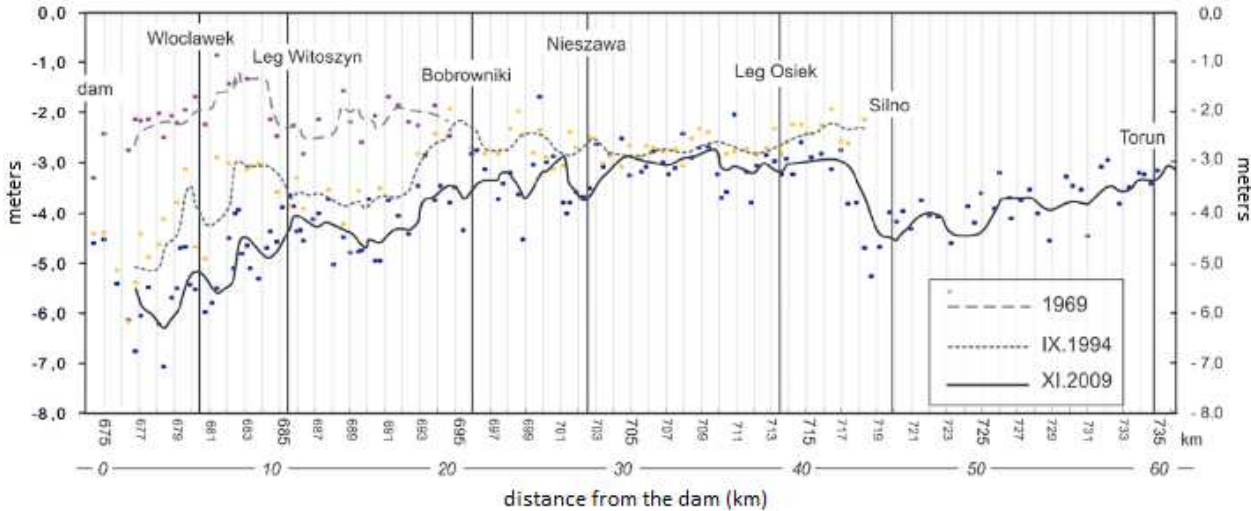
Figure 5 Change of hydraulic mean riverbed depths in time (points on chart). Continuous line denote moving average

Variations in depths with tendency to decrease downstream from the dam, confirm a general trend of riverbed erosion process below dams (Chalov et al. 2001, Wang et al. 2004). Comparison of mean depths, which were calculated for cross sections of 1969 and 2009, indicates increase of a mean depth of the channel on average by 3,5 m in the vicinity of the dam (Figure 5) (Habel 2013).

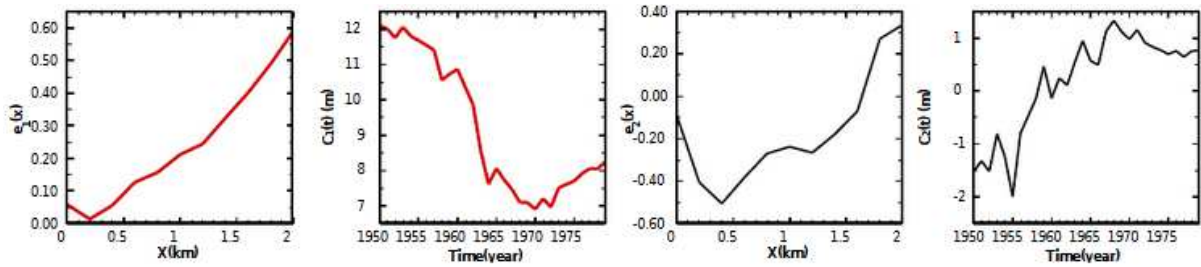
Figure 8 Exemplary outputs of temporal and spatial eigenfunctions for 1st and 2nd modes of the riverbed variation (on the basis of Teodori River, Japan)

Outputs of the EOF analysis are usually represented in graphs. Figure 8 is exemplary description of spatial and temporal eigenfunctions for a segment of Teodori river in Japan. The first spatial function $e_{1(x)}$ (graph from the left) corresponds to the mean riverbed profile during defined period of time, whereas temporal function $c_{1(t)}$ is related to the curve representing temporal variation in volume of sediments/erosion.

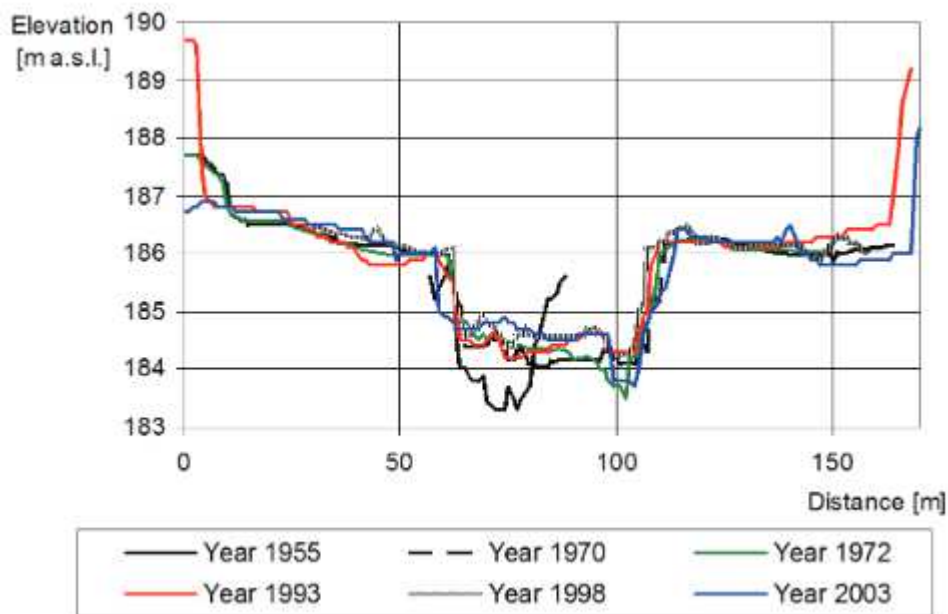
Figure 9 Exemplary visualisation of analysis of changes in geometry of riverbed on the basis of cross – section of Nida river

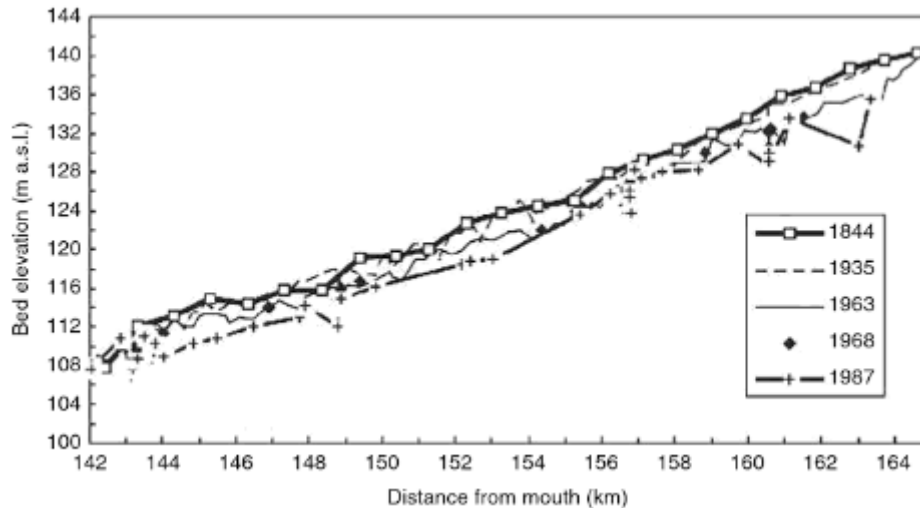
Figure 10 Exemplary visualisation of multi – temporal longitudinal profiles on the basis of Arno River (Italy)

Similarly as in case of cross – sections, longitudinal profiles can be analysed on the basis of short and long - term periods. Analysis of multi – temporal profiles ensure direct information on spatio – temporal propagation of changes. Plotting the variations in riverbed elevation for different time periods versus distances downstream ensures an effective way to make visualisation of the spatial distribution and amount of riverbed elevation changes (Figure 10) (Rinaldi 1998).

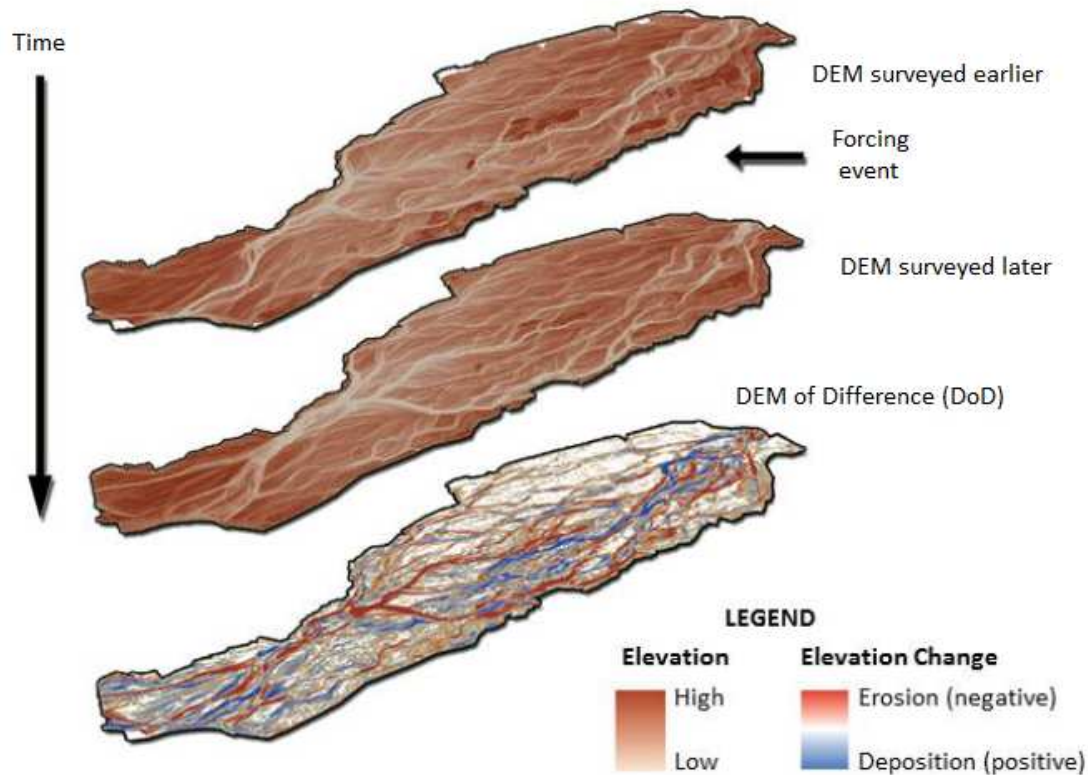
Figure 12 Example of generation of DEM of Difference of Rees River (New Zealand)

DoD approach is based on mathematical algorithm for assessment volumetric changes of landforms on two different time periods (Wheaton et al. 2010). The timeframes of analysis can be extended to decades if only accurate historical DEMs can be generated. Creation of DoDs usually is related to subtraction of one elevation model from another to disclose a mosaic of morphological change. Typical path is to subtract DEM that was surveyed earlier by the DEM that was measured later (Figure 12).

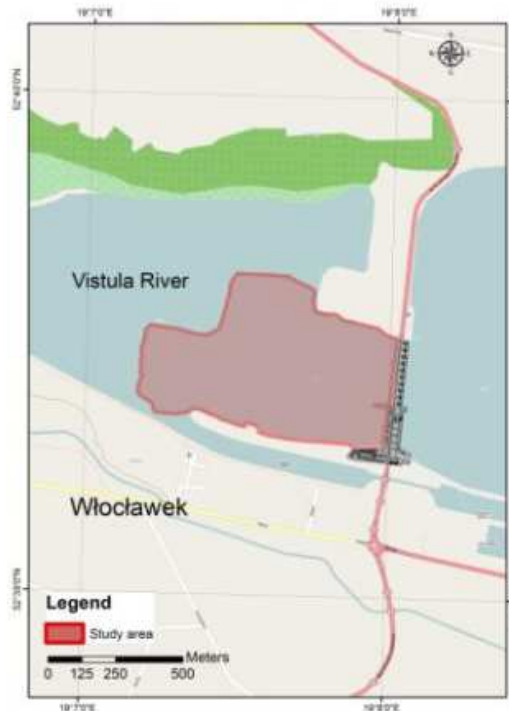
Figure 15 Study area of the lower Vistula river

The study area contained the lower part of the Vistula river in direct vicinity of the power station. The size of the area covered by surveys amounts to 300 x 400 m. Its location is presented in the Figure 15. Decision on the location and the extent of study area was made on the basis of occurrence of accelerated erosion of the riverbed below the dam caused directly by the operation of hydroelectric facility.

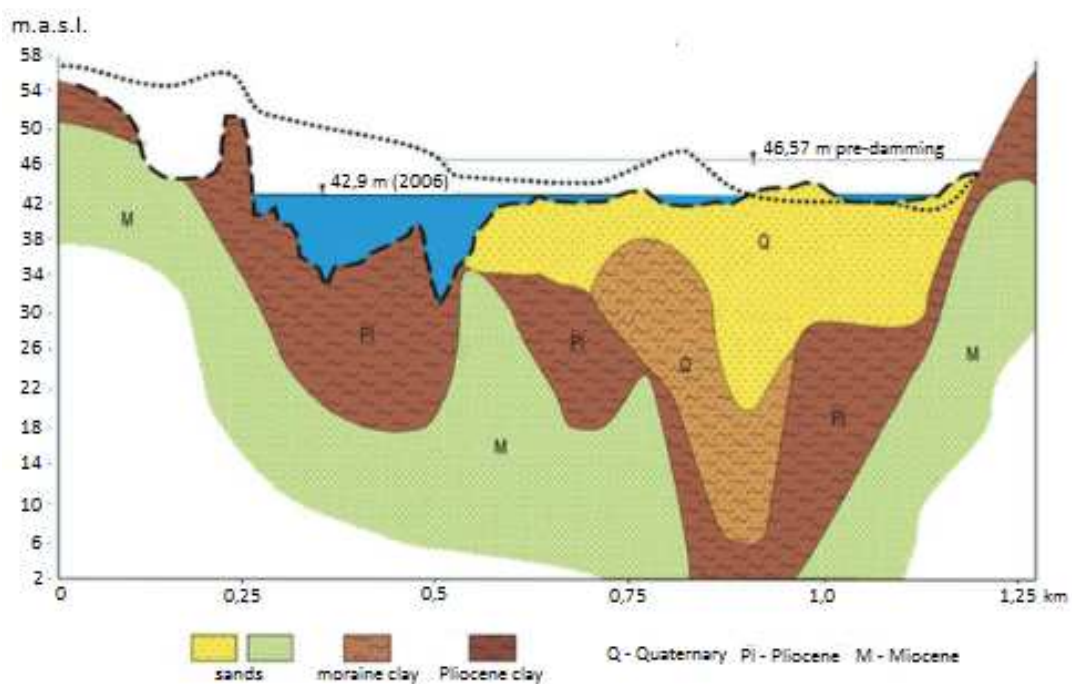
Figure 16 Geological structure of lower Vistula in cross – section in the vicinity of Włocławek dam

The geological structure of the lower Vistula is shown in the Figure 16. At one of the exposed fragment of a gravel pit (right side of the channel), ice – marginal, gravel and sand layer are overlaid by the layer of moraine clay. They are isolated from each other by a thick layer of fine sands (Babiński 1982). The part of fluvial sand sediments, with the upper section that reach the elevation up to 60 – 66 m a.s.l., at some fragments can be found at the top of moraine clay, which may constitute a proof for multiple glaciations. The opposite Dobrzyń Moraine Plateau, presents a similar geological structure. The drillings made in that cross – section indicated geological structure of three layers of moraine clay, separated with the layers of sand formations or Pliocene clays (Habel 2013).

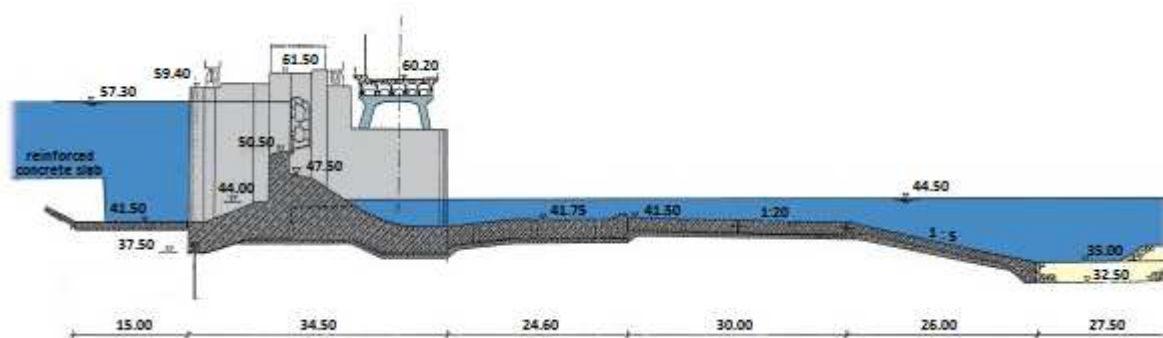
Figure 17 Long section of the weir and its fortifications

Włocławek hydroelectric power plant is located on the cross section of Vistula river on 674,85 km. It was constructed in 1970 and till now is one of the biggest hydropower plants in Poland. The dam was designed as the first part of the contemporarily planned Lower Vistula Cascade. The ordinate of 44,50 m ASL was designed for the water on the next station supposed to be constructed, whereas changed slope influenced the calculations of safe filtration of the dam and substrate of all facilities and its stability. The basic measurements and ordinates of the Włocławek dam are presented in Figure 17 (Habel 2013).

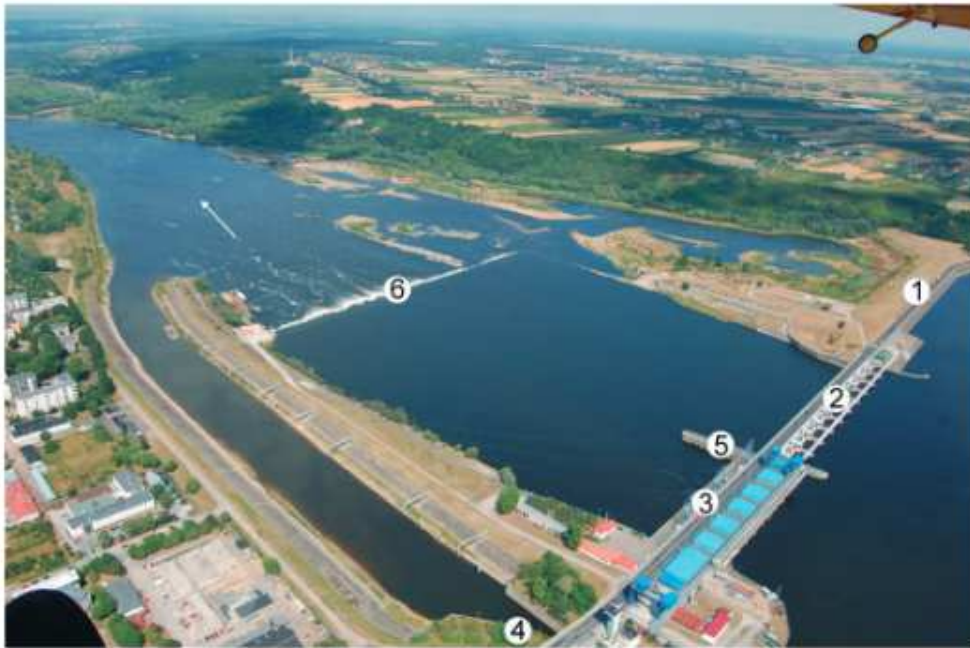
Figure 18 Hydroelectric power plant in Włocławek

- hydropower plant
- earth dam
- 10 weirs locked with sluice gates
- navigation lock with chamber and the designed water head 12,8 m

- fish – pass containing 30 concrete chambers in the dividing pillar and 3 rest – chambers with lure – water pipeline.

1 – earth dam, 2 – weirs, 3 – power plant, 4 – navigation dock, 5 – fish ladder, 6 – check dam (artificial sill) stabilizing the lower part of the dam

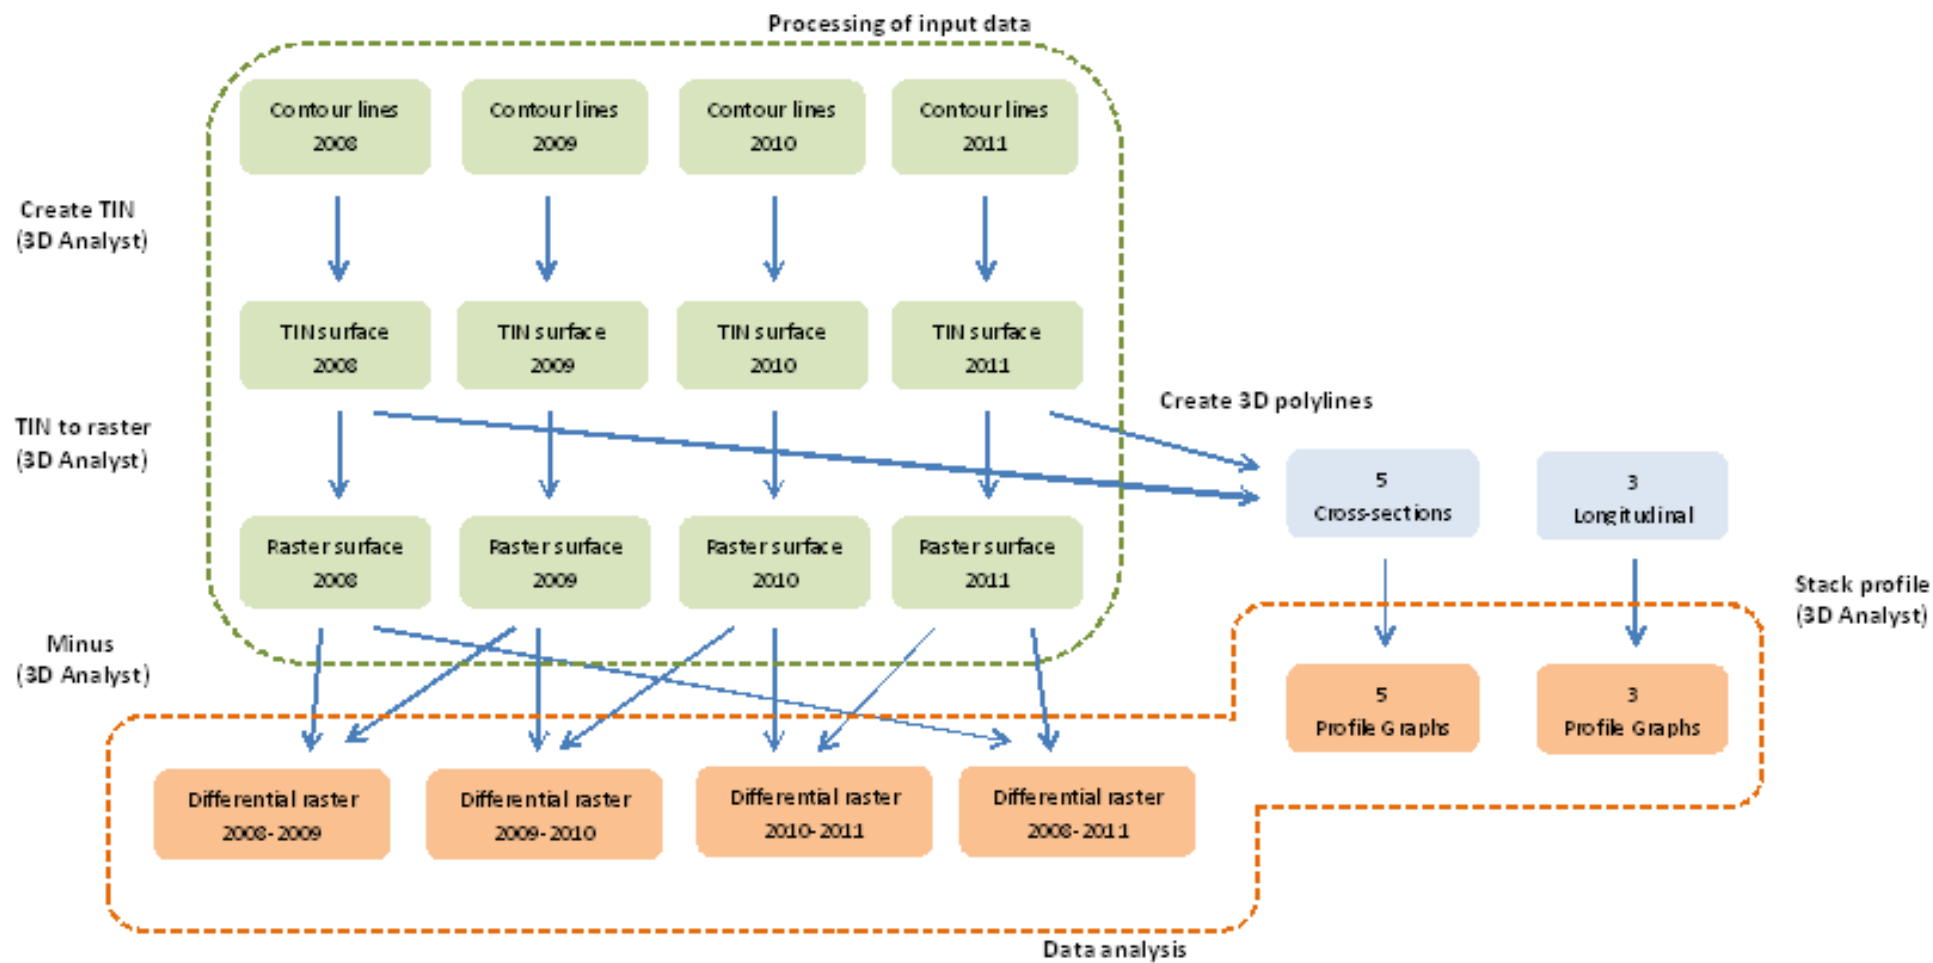
Figure 20 Scheme of workflow overview

The objective of the study is determination of Vistula riverbed changes in the vicinity of Włocławek barrage as a result of progressive erosion and operation of hydroelectric power plant. To define spatio – temporal variations in a quantitative way, identification of spatial distribution of morphological processes and its dynamics over time was carried out by the means of volumetric analysis. The input data were acquired from the Chair of Satellite Geodesy and Navigation of the University of Warmia and Mazury in Olsztyn, Poland already in the form of contour lines. Contour lines, in general are considered to be one of the most commonly used approach to provide information about elevation to map readers (Robinson et al. 1995). However, due to their coarse topological structure, they are not suitable for spatial analysis of ground morphology as even slope or shaded relief maps derived from contour lines are a rather cumbersome operation (Carrara et al. 2010). Despite that fact it was decided to use acquired contour lines in the master thesis, as for the reason of confidentiality of original source survey data - they were not possible to obtain. Because shared data were already in the form of digital contours, DEM was considered to be an accurate mean to visualisation of riverbed surface and to conduct detailed spatio – temporal analysis. The general scheme of the workflow and its particular steps is presented in Figure 20.

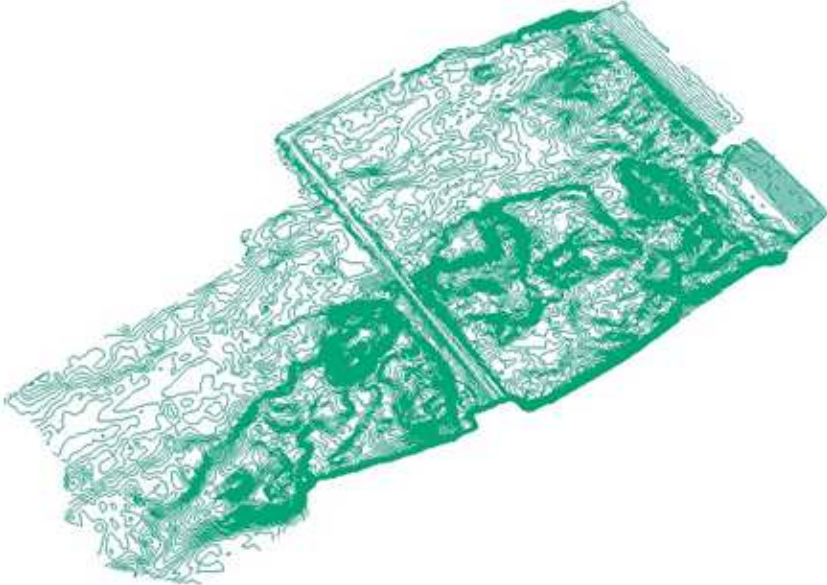
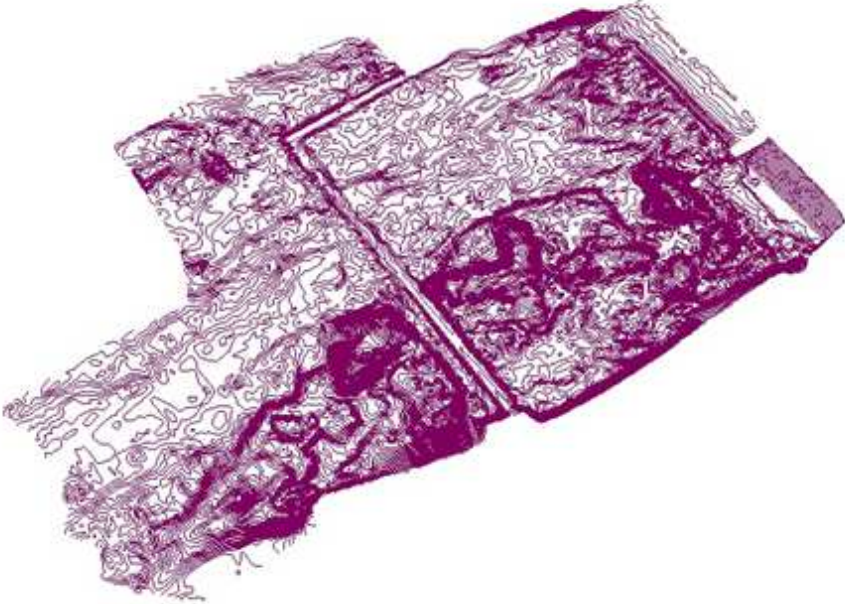
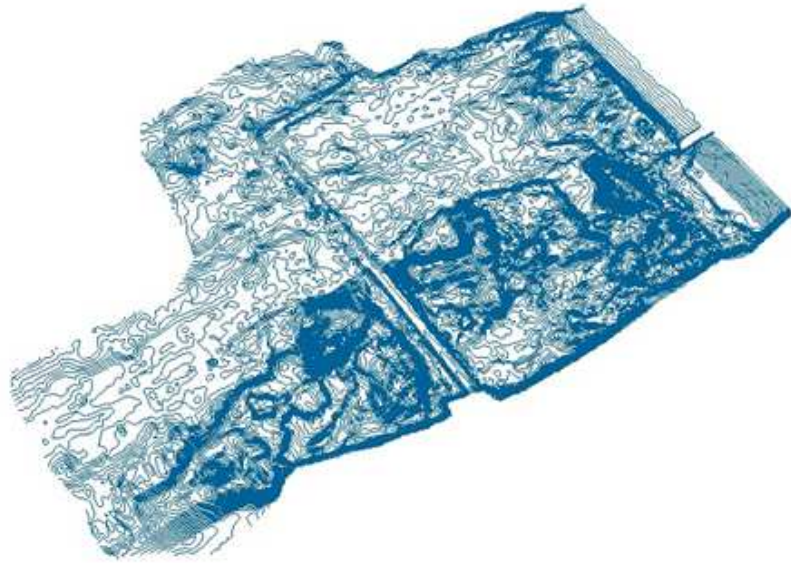
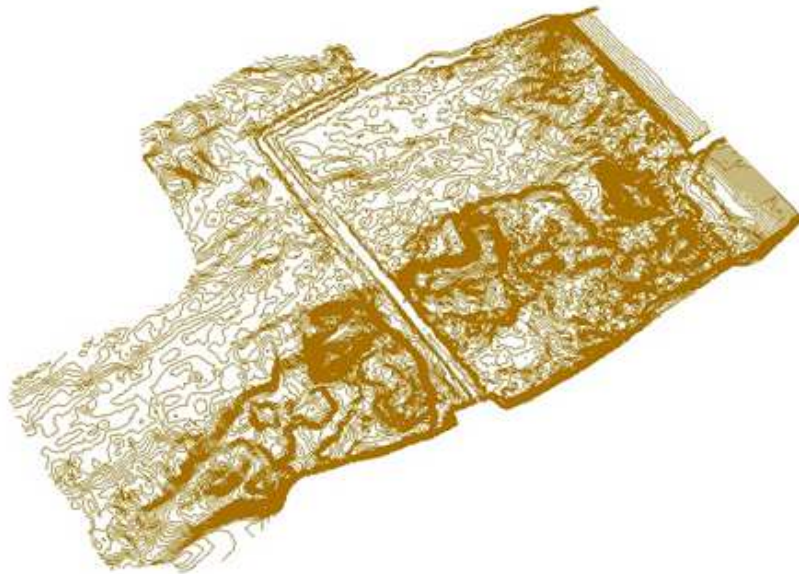
Figure 21 Contour lines generated from the measurement data points for the year 2008

Figure 22 Contour lines generated from the measurement data points for the year 2009

Figure 23 Contour lines generated from the measurement data points for the year 2010

Figure 24 Contour lines generated from the measurement data points for the year 2011

According to information provided by scientists from Chair of Satellite Geodesy and Navigation of the University of Warmia and Mazury in Olsztyn, due to a large set of points and interest in the spatial variation over the smoothness of the overall surface, Inverse Distance Weighted (IDW) interpolation method was applied into creation of provided contour lines. Generated contour lines for particular measurement campaigns are presented in Figures 21 - 24.

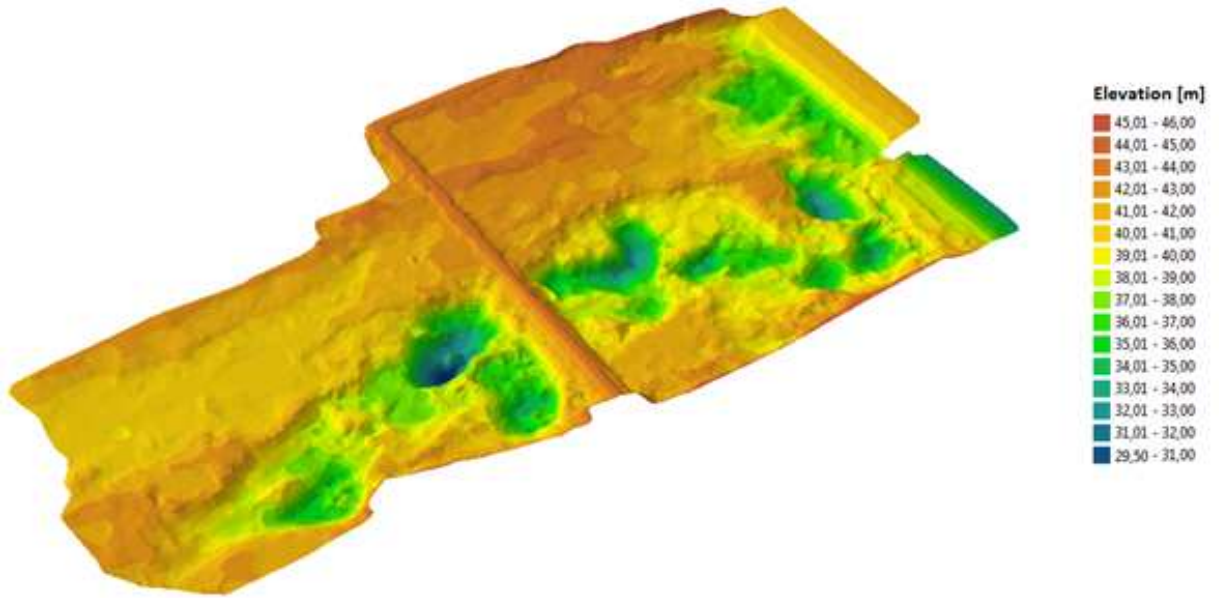
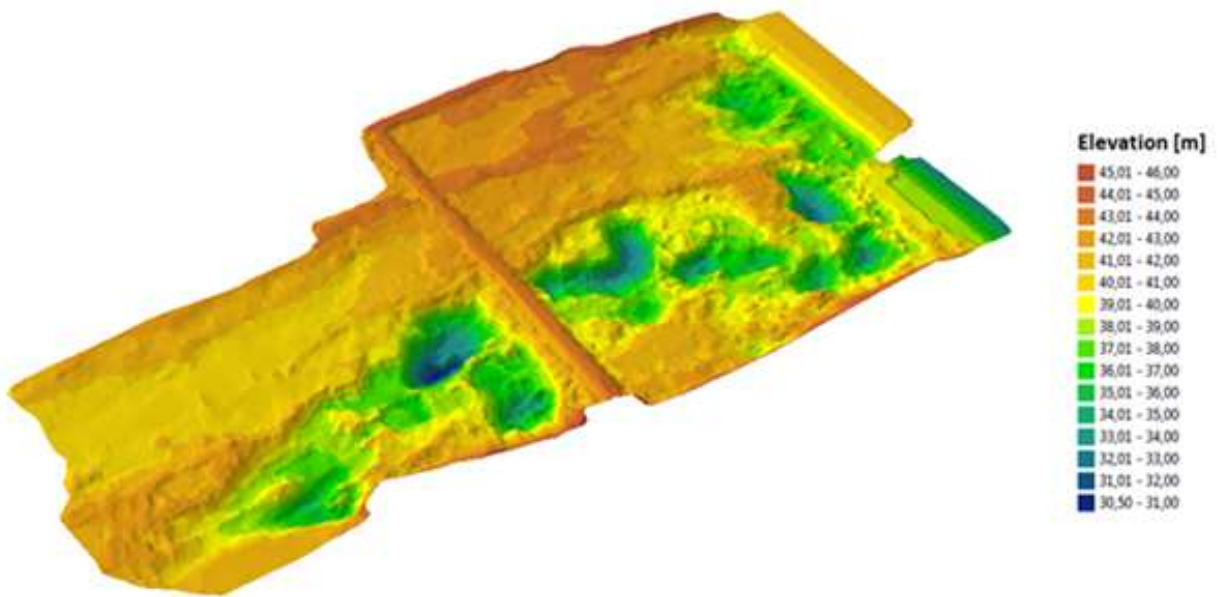
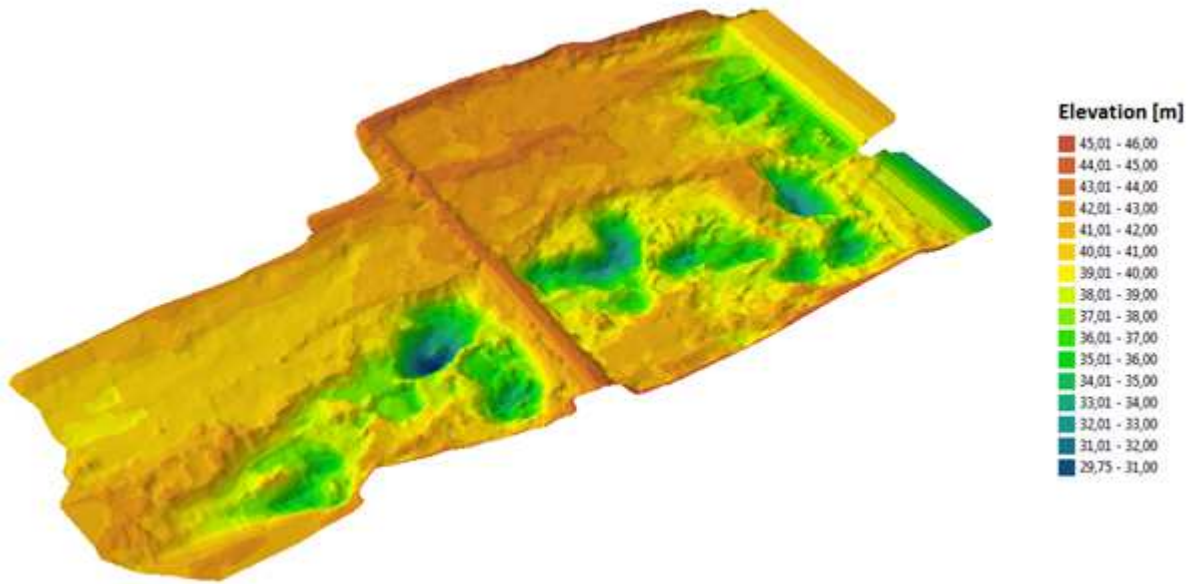
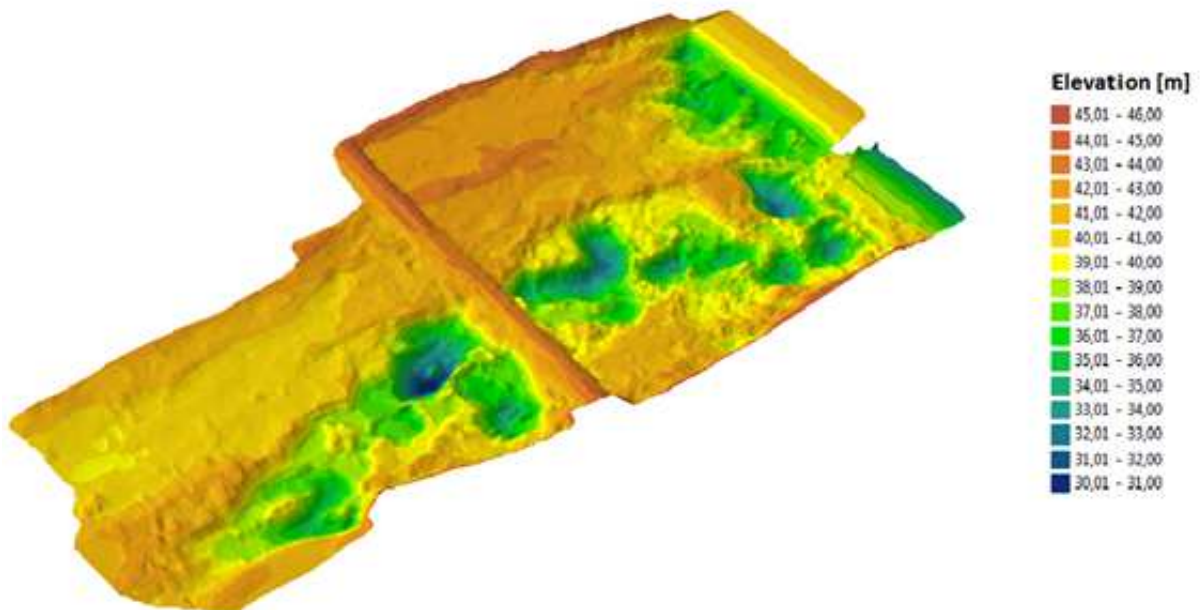
Figure 25 DEM generated for survey campaign from 2008

Figure 26 DEM generated for survey campaign from 2009

Figure 27 DEM generated for survey campaign from 2010

Figure 28 DEM generated for survey campaign from 2011

On the basis of the contour lines, 3D Triangular Irregular Networks (TIN) models were created for particular measurement years (Figure 25 - 28). In order to represent the shape of riverbed best, elevation values were divided into 16 classes with the interval of 1m. To emphasize changes in the surface elevation a vertical exaggeration was implemented at the level of 3. Generated models were the basis for further spatial analysis.

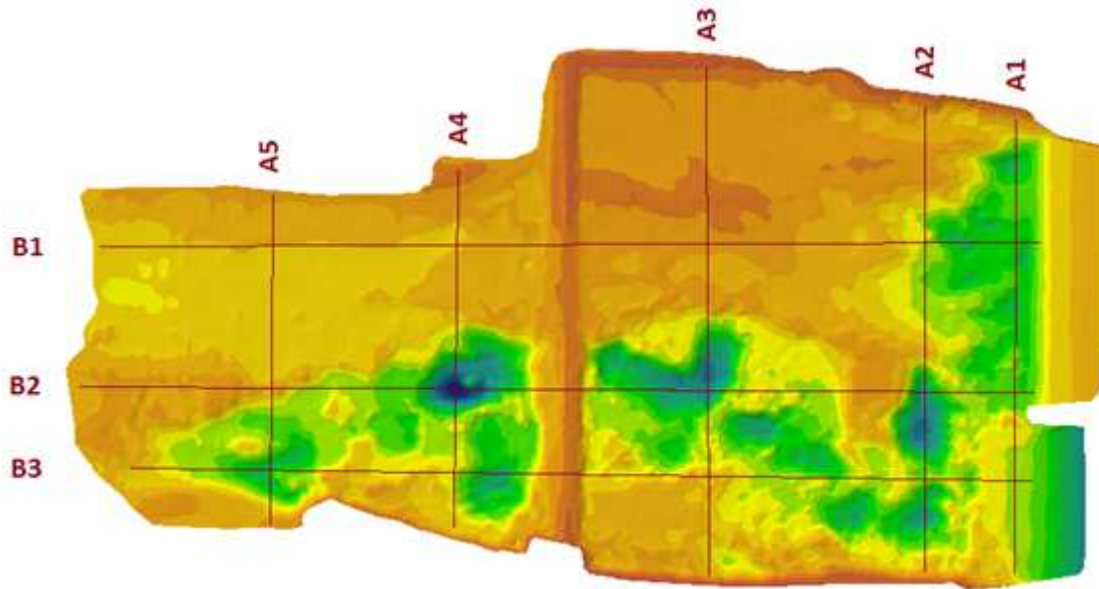
Figure 29 Designed profile lines distributed over the survey area

The differential analysis were based on DoD method, using 3D Analyst tool called Minus. The tool subtracts the values of the second input raster – in this case the older DEM, from the values of the first input raster – the newer DEM, on the cell-by-cell basis. Additionally, based on the results of the differential analysis, it was decided to analyse more precisely the riverbed elevation by means of longitudinal profiles and cross - sections. Eight profiles have been designed – 5 cross sections marked with letter 'A' and 3 longitudinal ones marked with letter 'B' (Figure 29). Their location was chosen in such a way, that the profiles pass through the most significant areas regarding elevation changes. In order to represent the general tendencies of morphological processes, the profiles were analysed in the timeframes of 4 years.

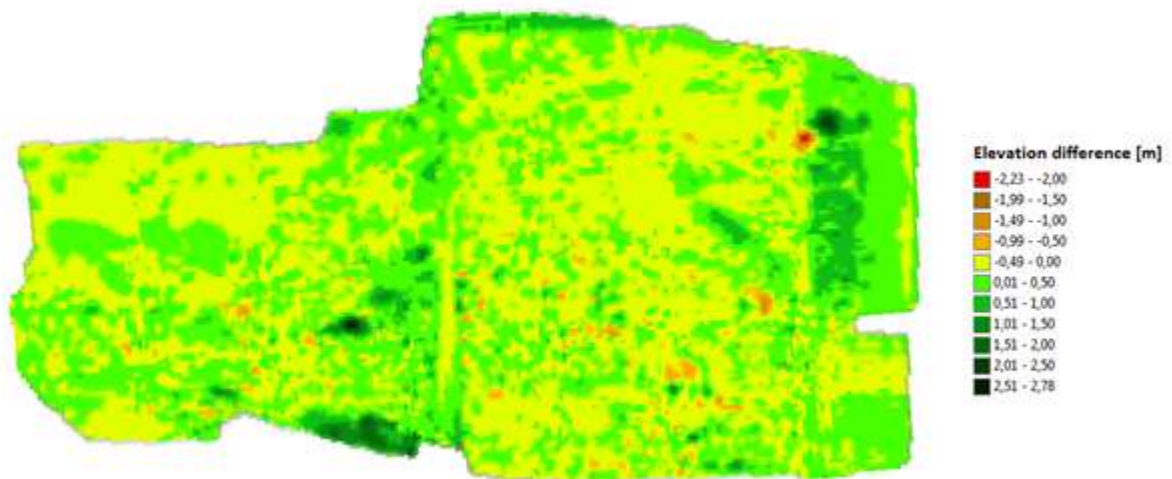
Figure 30 Comparison of elevations of 2009 to 2008 model

Regarding DoD approach, comparison of 2008 and 2009 models shows the distinct changes in the elevation over the whole surveyed area. A vast surface of the riverbed is characterized by bed incision within the range reaching up to 0,50 m. On some part of other areas a tendency to accumulation of sediments is represented. There is also a number of small spots scattered throughout the whole area with a structure loss reaching 1,0 m – 2,0 m dependent on the location. The biggest ones are identified in the north – east part of analysed area, in the neighborhood of the dam with the values up to 2,0 m. There are also located areas with the significant increase in the elevation of the riverbed.

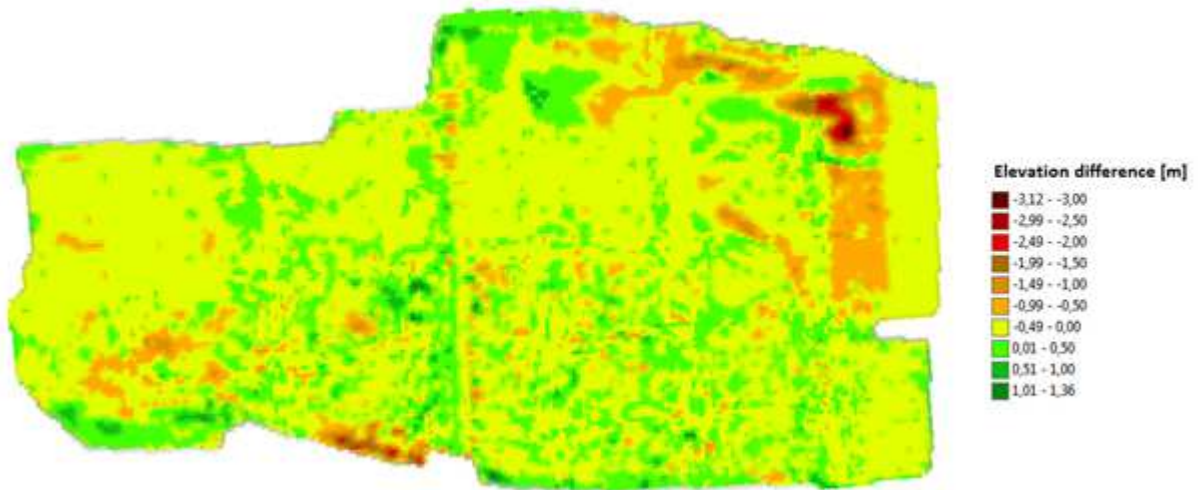
Figure 31 Comparison of elevations of 2010 to 2009 model

Surveys carried out in 2010 showed a further tendency of riverbed degradation of Vistula. The vast majority of the analysed area decreased up to 0,50 m. The biggest loss in the structure amounted to more than 3,0 m is noticed again in the north – east part of the analysed area, in direct neighborhood of the dam. There are also located the biggest areas of lowered riverbed in the range from 0,50 m to 2,0 m. The elevation changes occurred in the period of one year difference are significant.

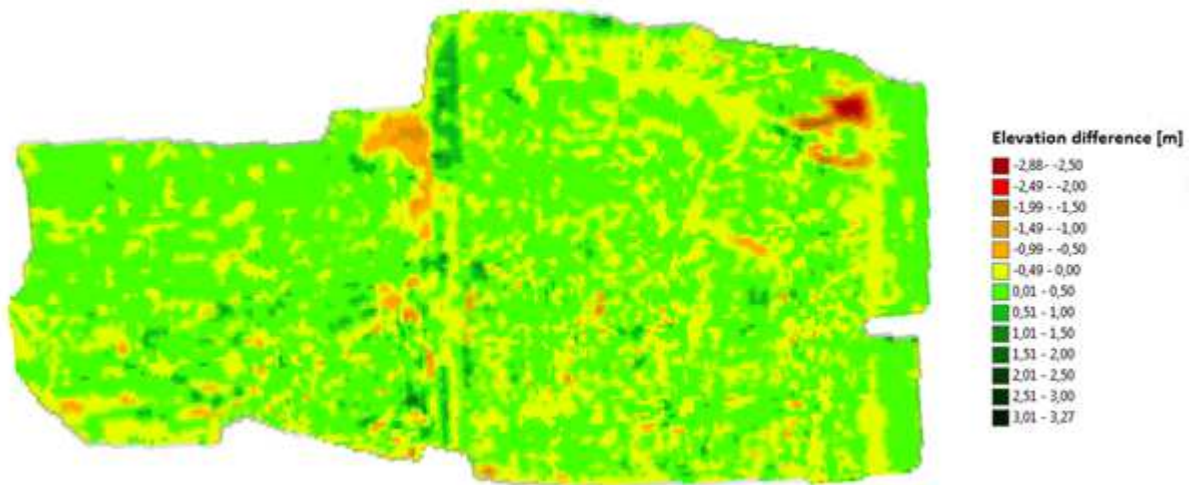
Figure 32 Comparison of elevations of 2011 to 2010 model

In contrast to comparison of 2009 - 2010 models, the analysis of elevation difference between 2010 and 2011 models showed a little bit different tendency.

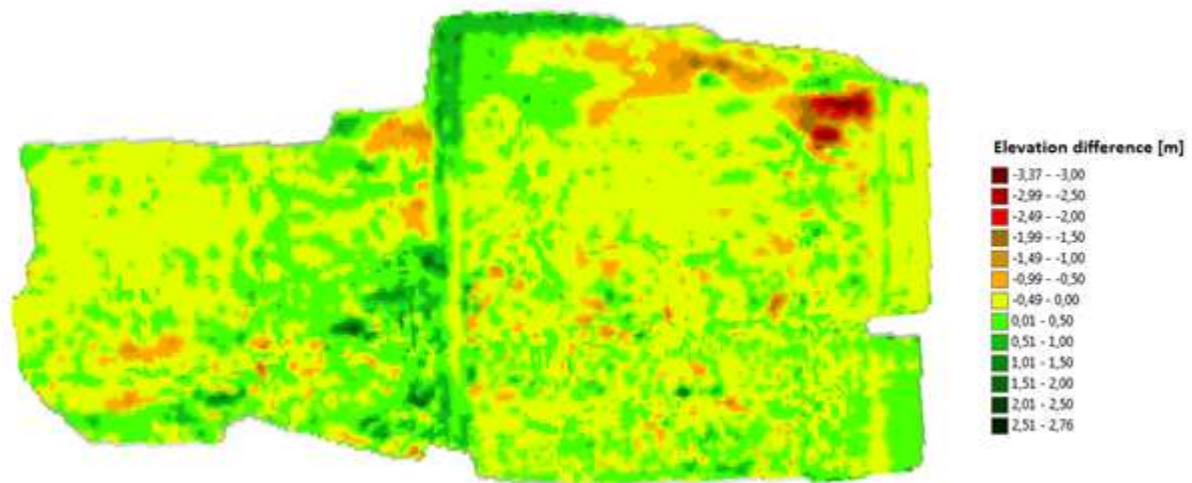
Figure 33 Comparison of elevations of 2008 and 2011 models

Comparison of 2008 – 2011 models, represent the total elevation differences over the 4 years.
