Master Thesis

Spatio-temporal changes of Vistula riverbed below the Włocławek hydropower plant

A thesis submitted in partial fulfilment of the requirements of
the degree of
Master of Science (Geographical Information Science & Systems) – MSc (GISc)

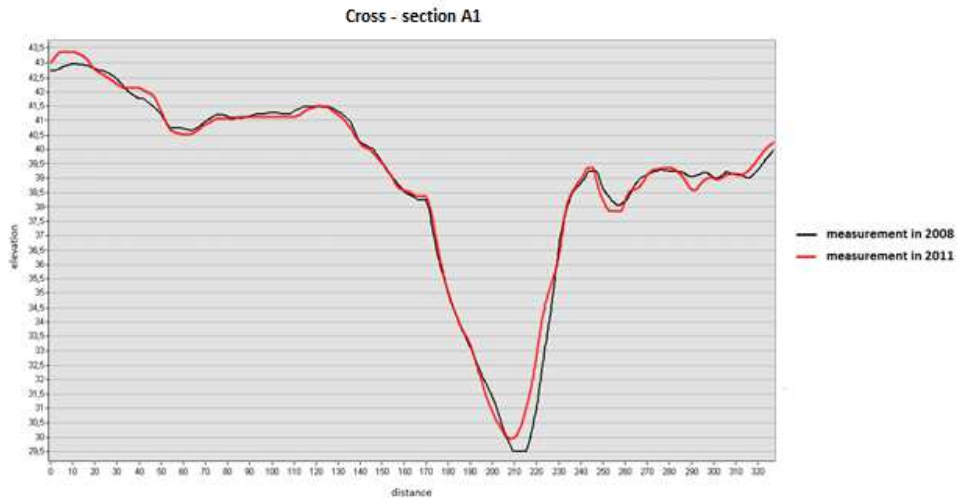
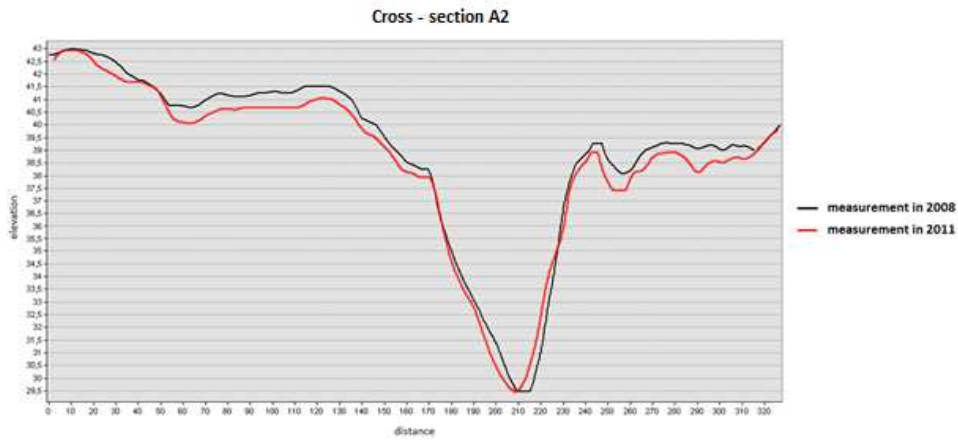
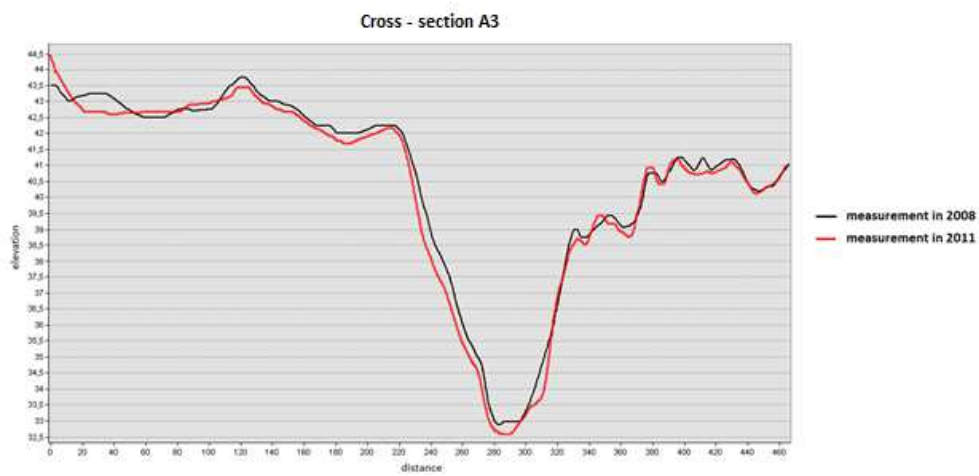
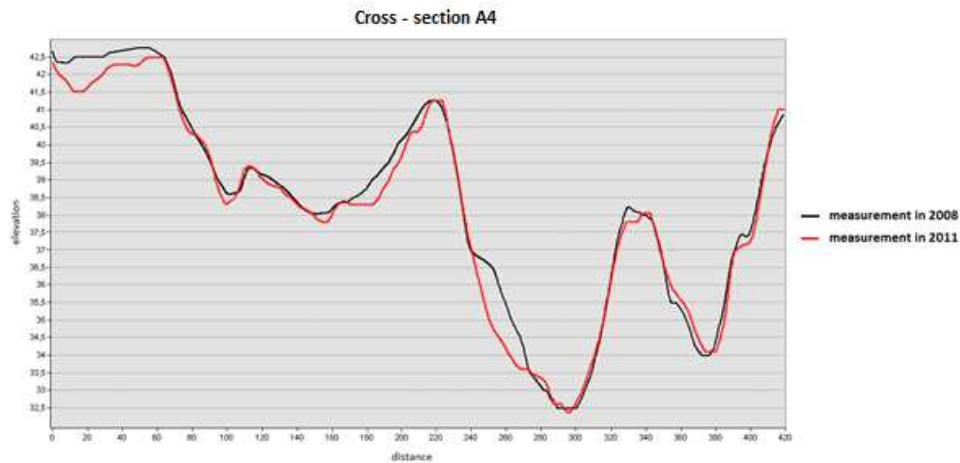
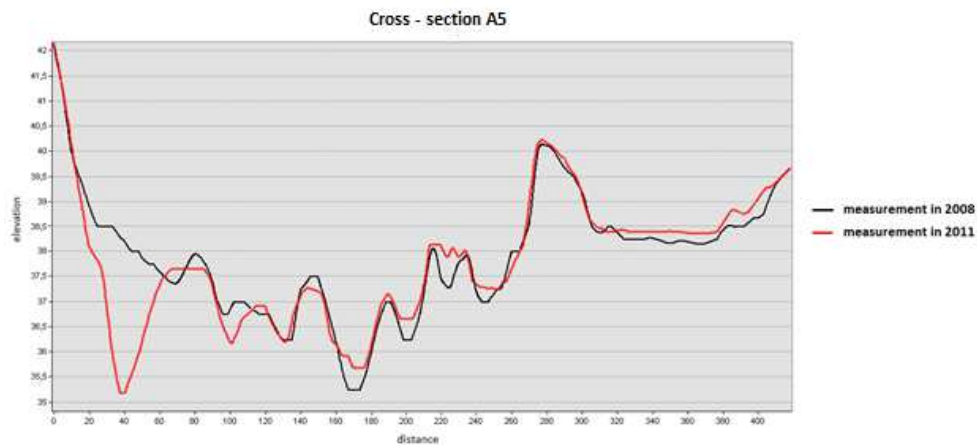
Figure 34 Elevation difference on cross – section A1

Figure 35 Elevation difference on cross – section A2

Figure 36 Elevation difference on cross – section A3

Figure 37 Elevation difference on cross – section A4

Figure 38 Elevation difference on cross – section A5

The analysis of cross – sectional and longitudinal profiles show the general information on the trends regarding morphodynamic processes occurring in the riverbed. Results for cross – section analysis are presented in Figures 34 – 38.

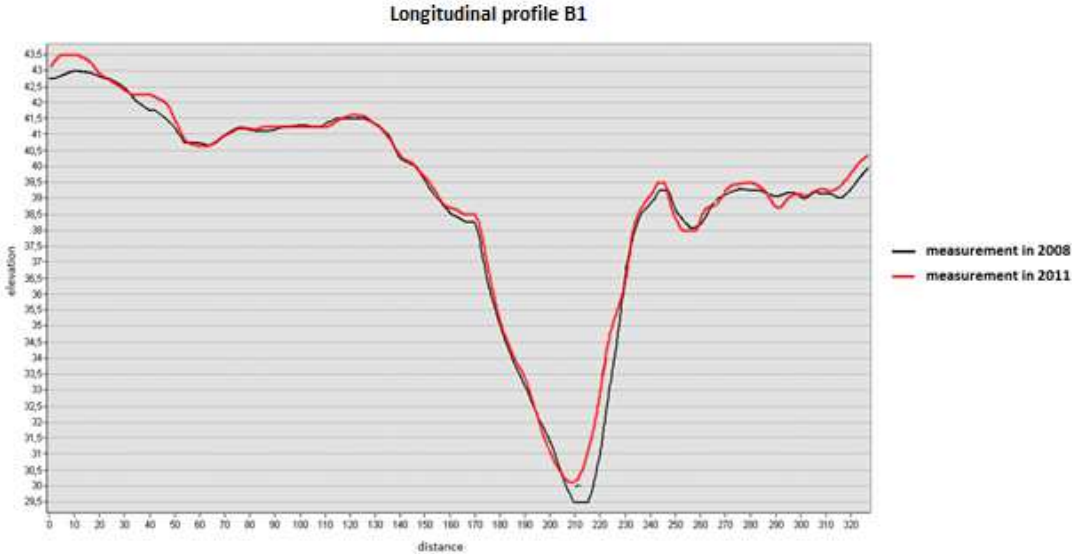
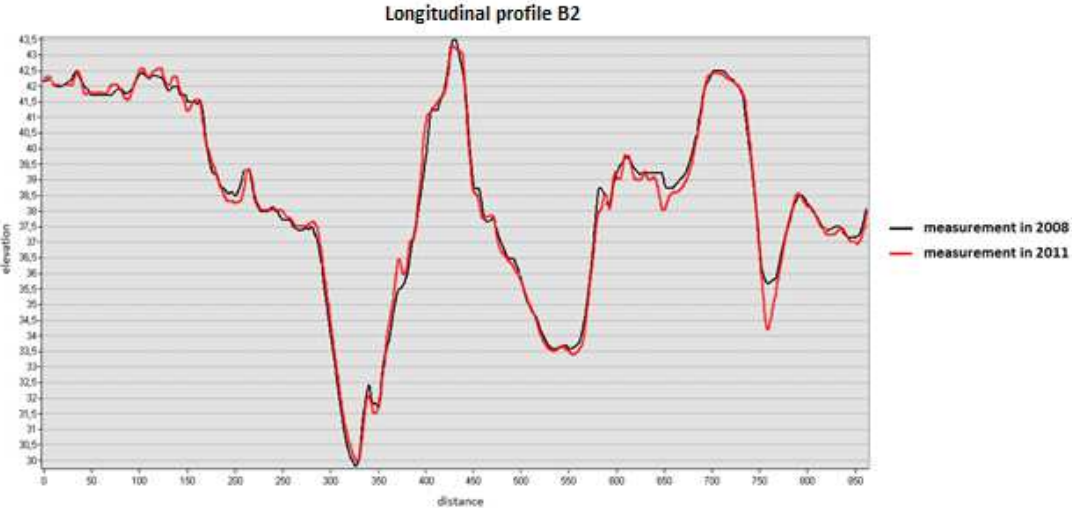
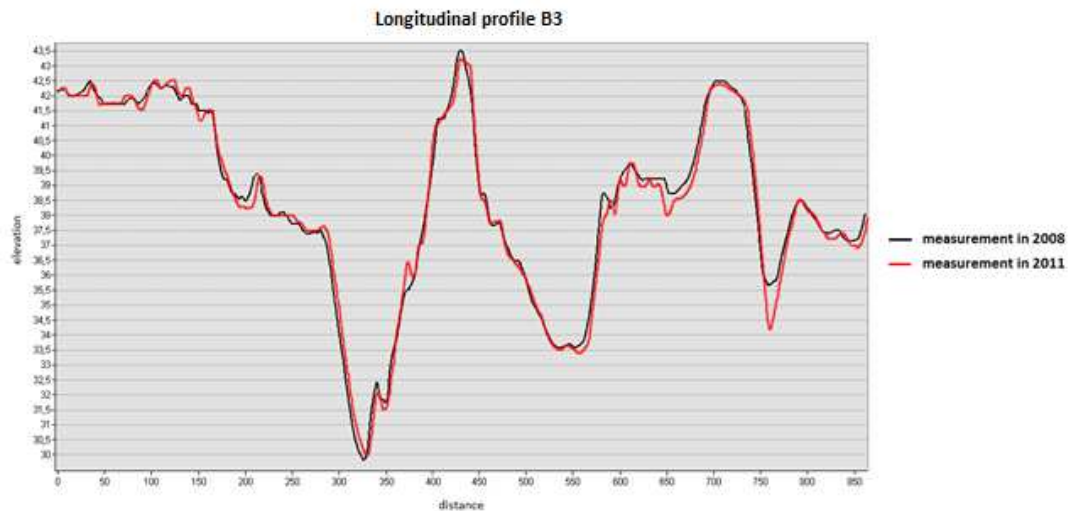
Figure 39 Elevation difference on longitudinal profile B1

Figure 40 Elevation difference on longitudinal profile B2

Figure 41 Elevation difference on longitudinal profile B3

Regarding longitudinal profiles, they do not demonstrate such big elevation changes as cross sections (Figures 39 - 41).

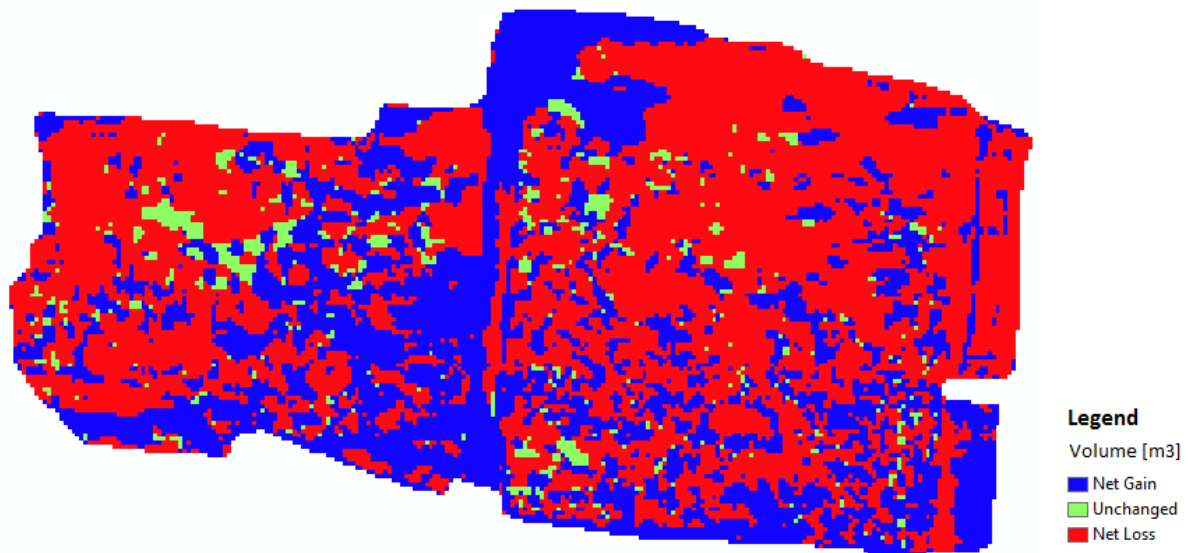
Figure 42 Evaluation of the volume of gained and lost material

To summarize all performed analysis, general evaluation of the volume of gained and lost material was considered to be best. On the basis of rasters from 2008 and 2011 the comparison of surface shape was conducted.

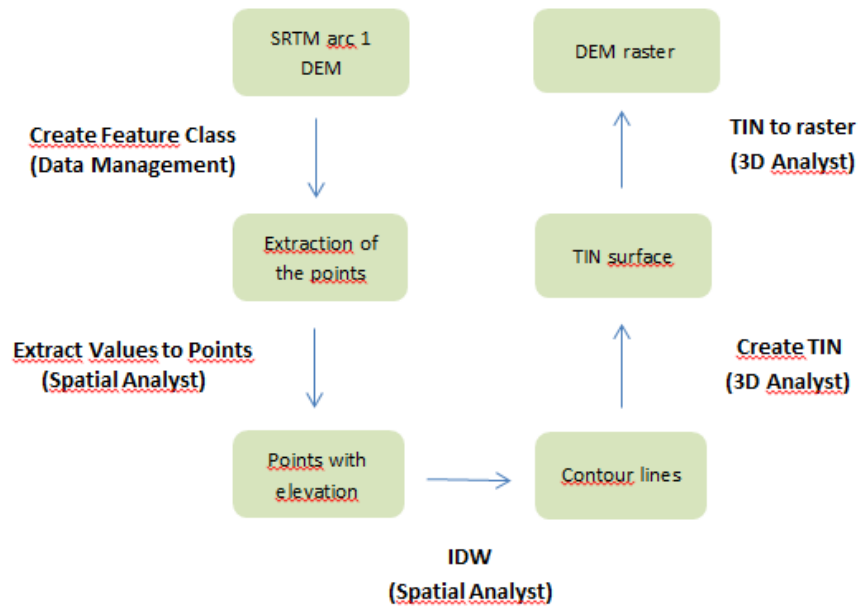
Figure 45 The workflow of accuracy assessment

Existing DEM for the analysis was acquired from the earthexplorer.usgs.gov portal. The part of SRTM arc 1 covering the landform with the elevation variance in the range up to 12 m was chosen as a reference surface for the analysis. On the area covering selected part of the DEM, a number of points with the same density as in the project has been created with elevation values extracted from the selected DEM. On their basis, interpolation with IDW approach has been conducted. Created contour lines were the basis for creation TIN surface, which were converted at the end to raster format.

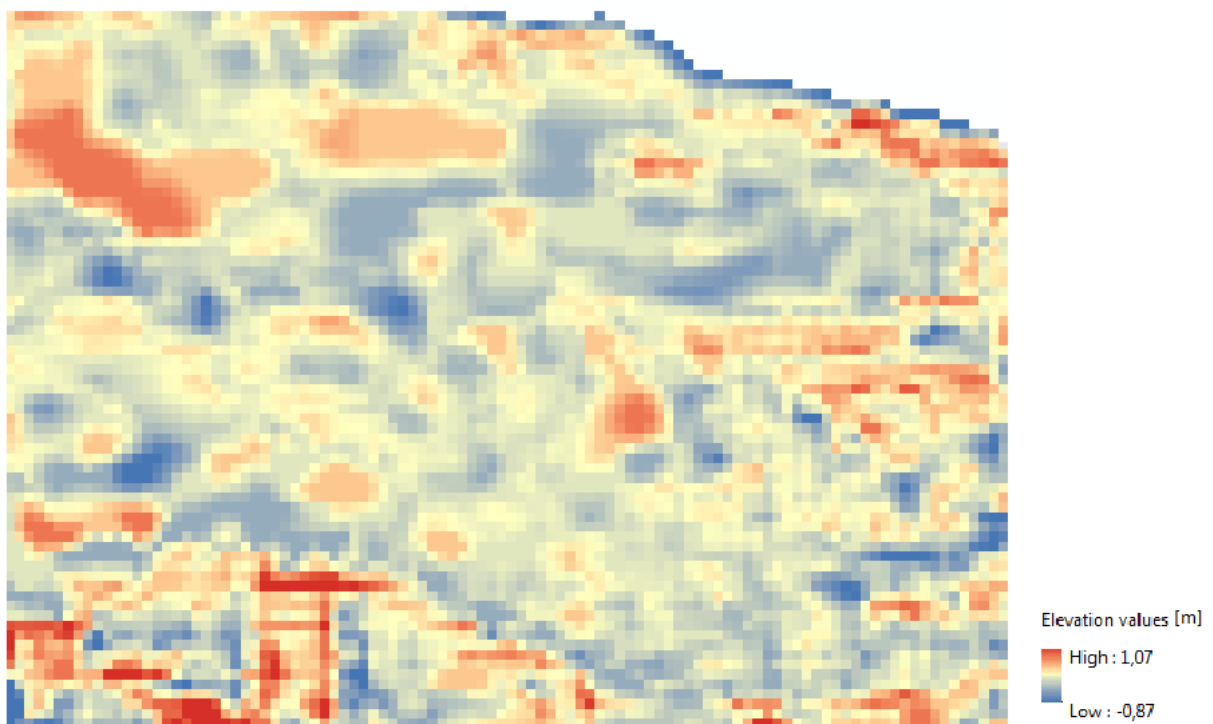
Figure 46 Assesment of elevation error magnitude

To define the magnitude of the error introduced to DEM derived from contour lines, the newly computed raster surface was compared to reference one using *Minus* tool. The results of that comparison are presented in Figure 46.
